City of Suffolk HISTORIC LANDMARKS COMMISSION

AGENDA
Historic Landmarks Commission Meeting
Thursday, September 9, 2021
9:00 a.m.

Subject: **Request for Certificate of Appropriateness HLC2021-00027**, submitted by Weimin Zhang, Wzhang Holdings LLC, applicant and property owner, for exterior alterations at property located at 127 Clay Street. The property is further identified as Zoning Map 34G18, Block A, Parcel 354, Suffolk Voting Borough, zoned CBD, Central Business District zoning district, and HC, Historic Conservation Overlay District.

STAFF REPORT

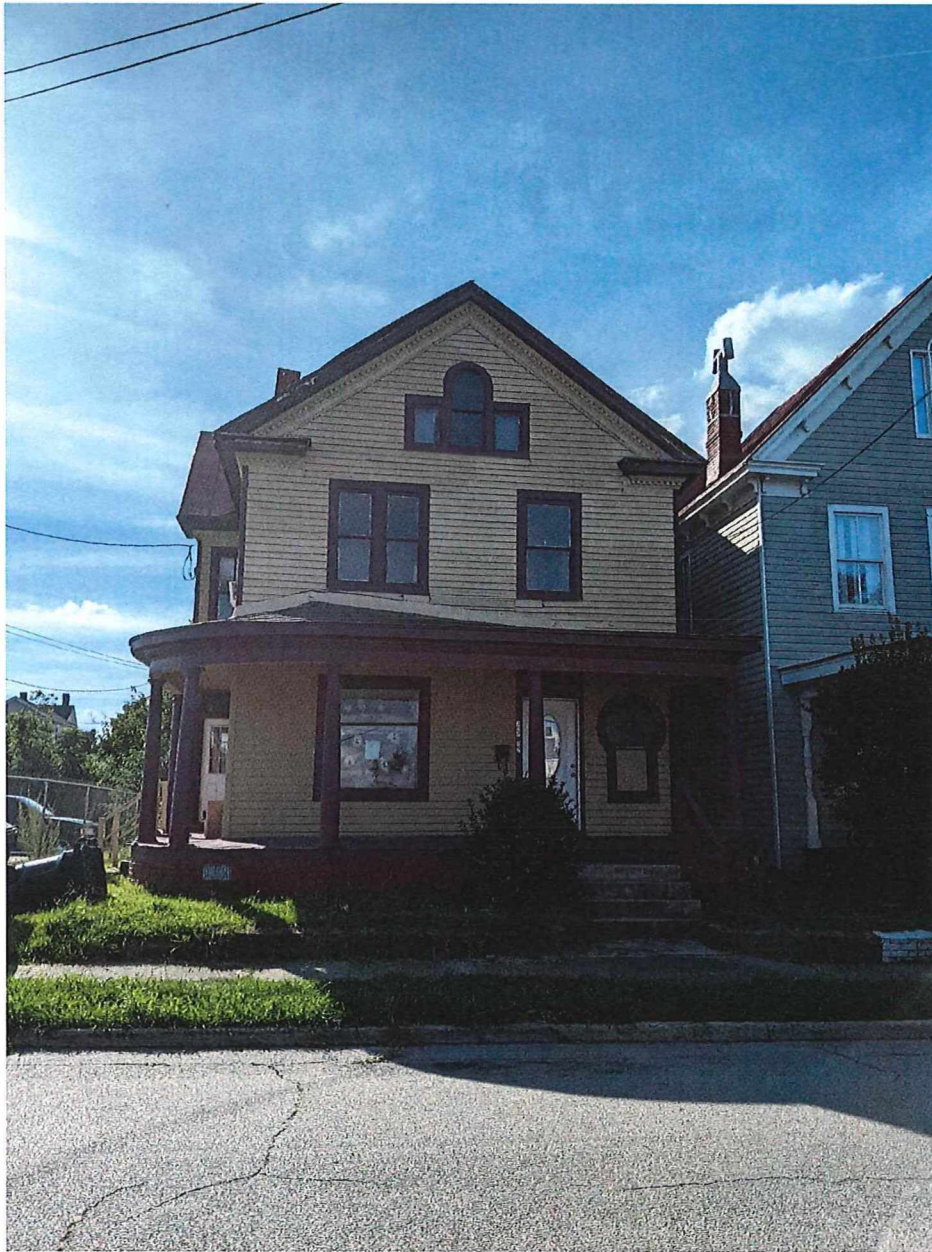
View of 127 Clay Street from Clay Street.

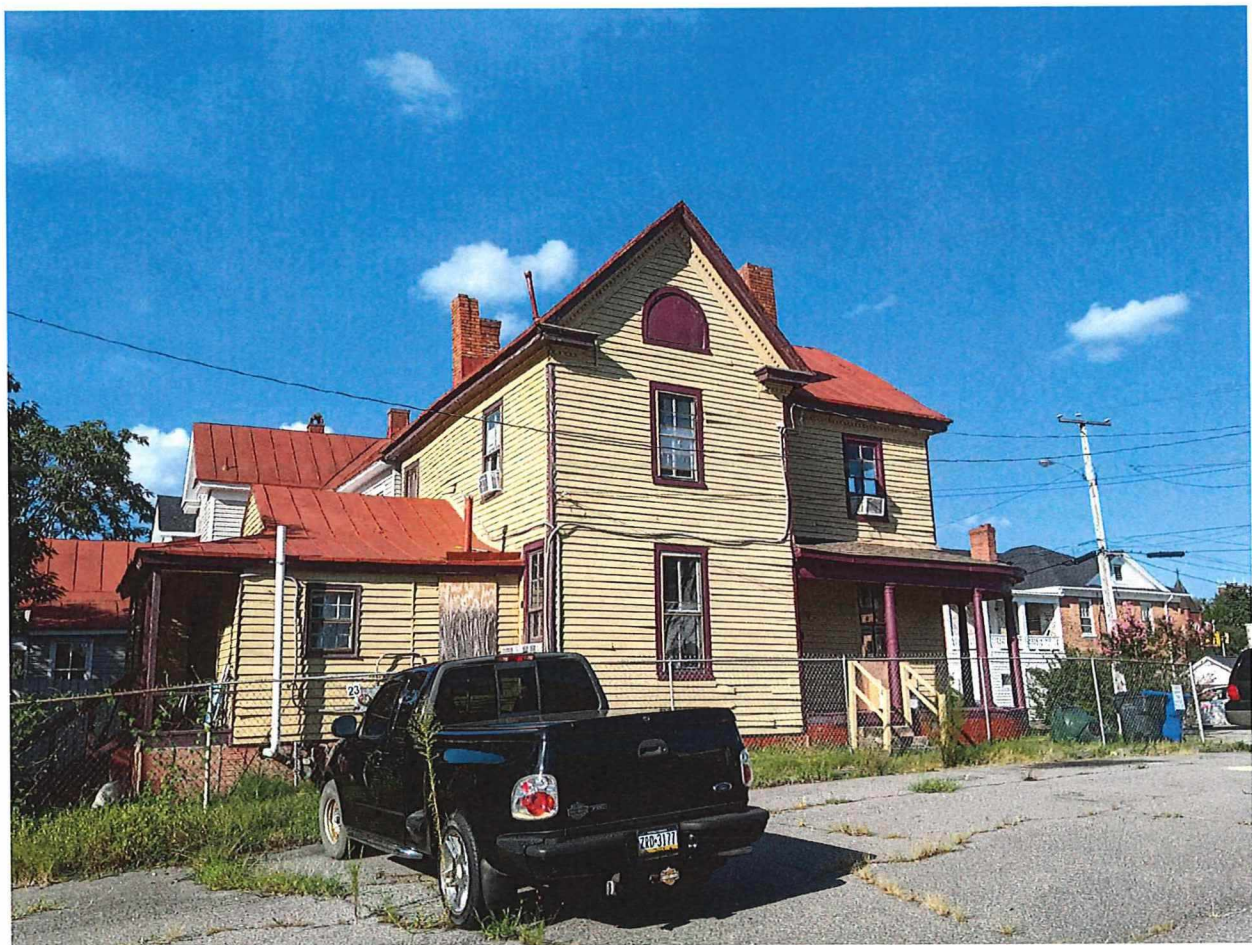
View of left side of 127 Clay Street from paved parking lot.

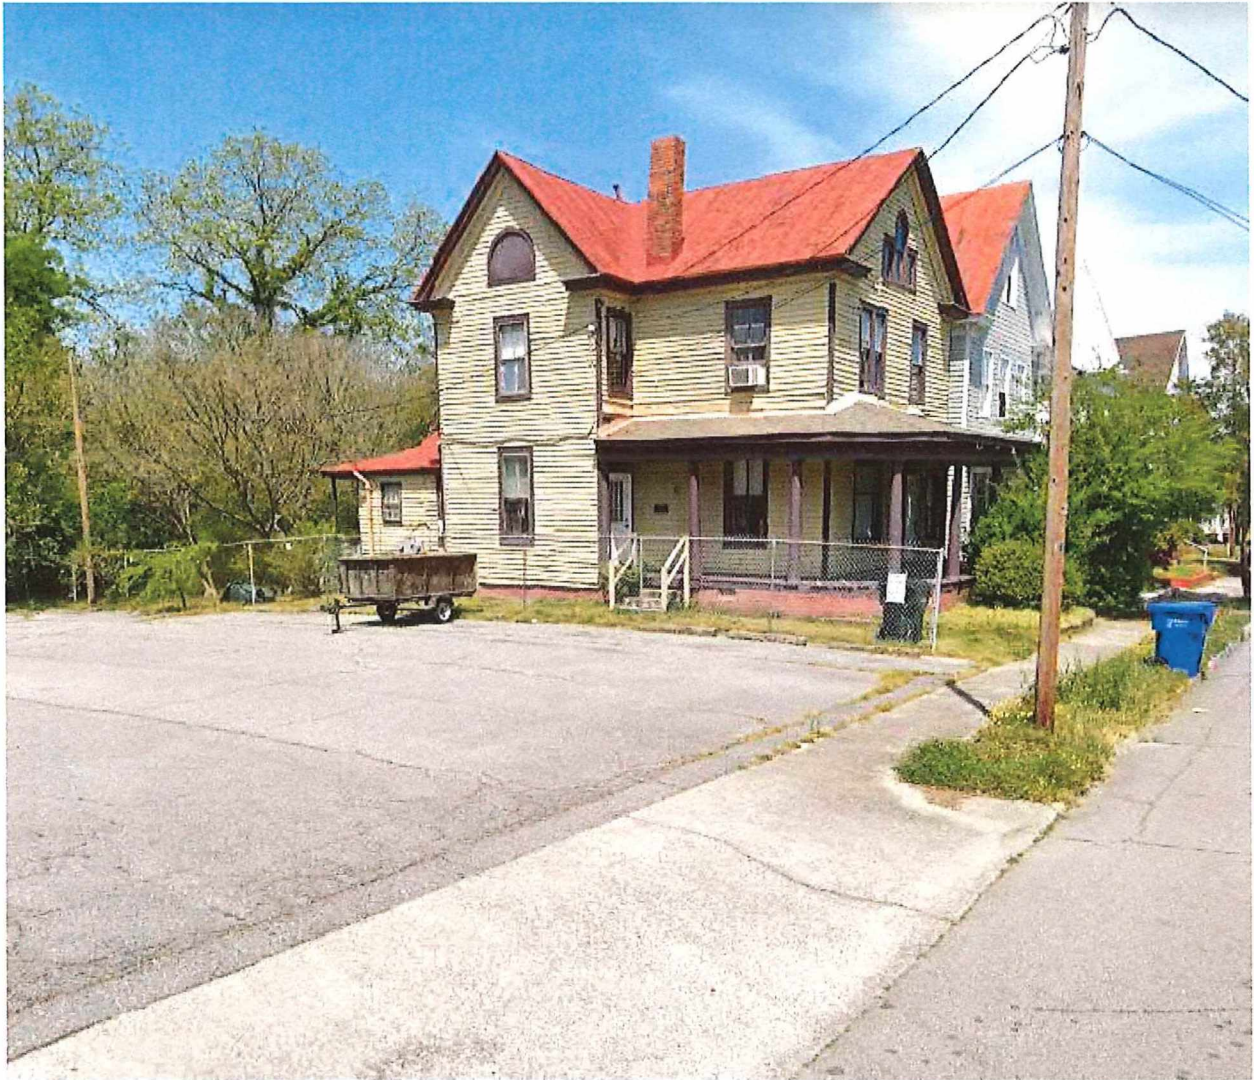
View of left side of 127 Clay Street from Clay Street.

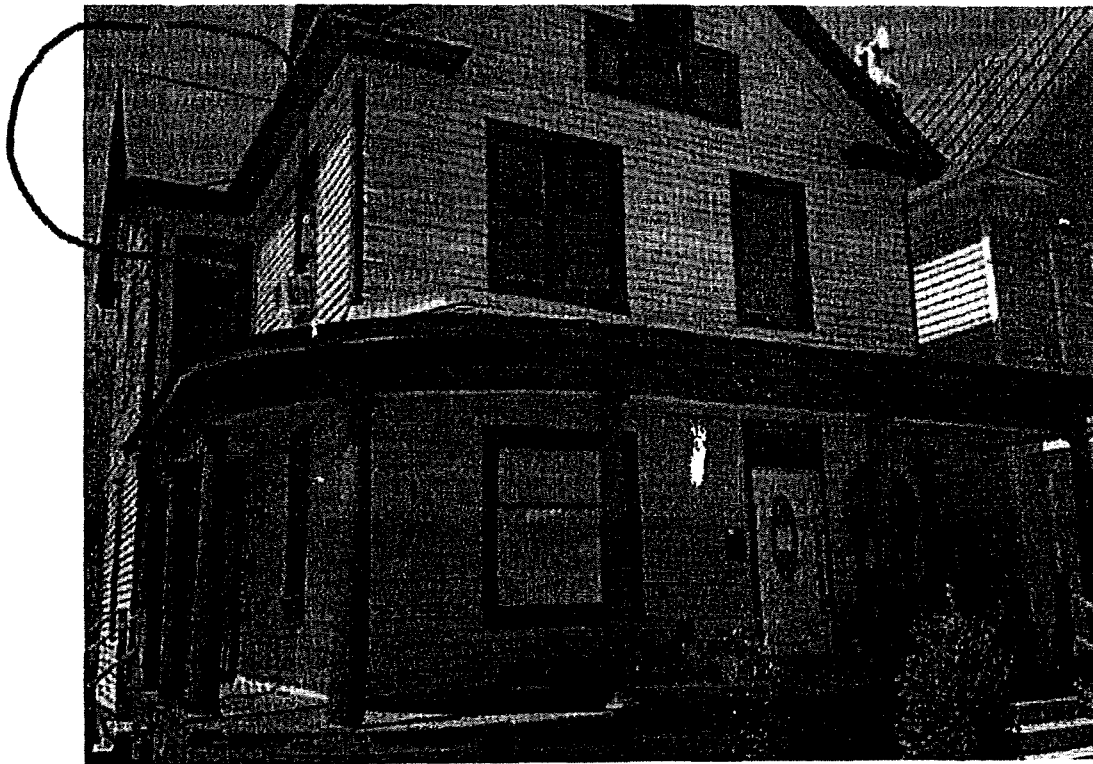
Picture 1 – existing roof

The roof of the house is beyond repair. Roof is loose and letting storm water inside the house framing. Moisture damage is heavy at visible exterior wood under damage roof. Moisture stains or damage are visible from exterior or likely present in sheathing, rafters, wall interiors, soffit and fascia framing, wall framing and joists. Roof is buckled in rear. Roof replacement is recommended due to the extent of the damage and scope of repair.

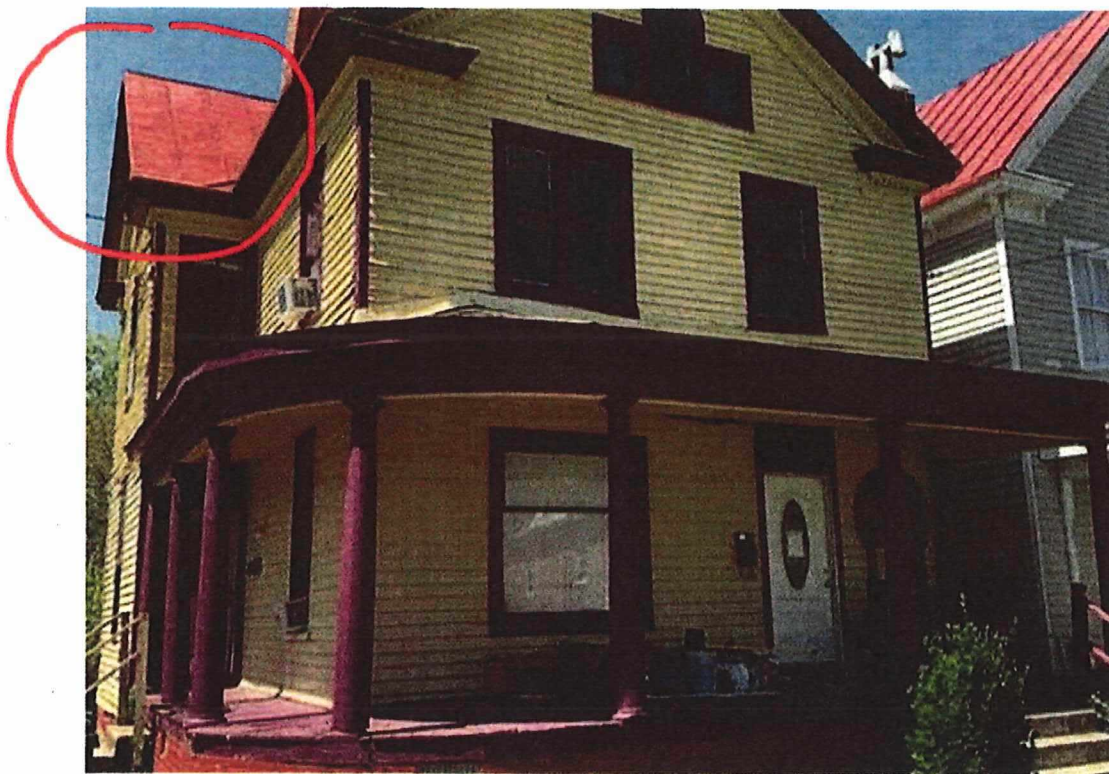
Picture 2 – Poor condition of existing roof

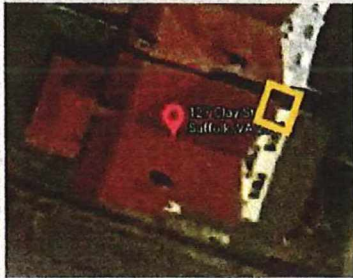
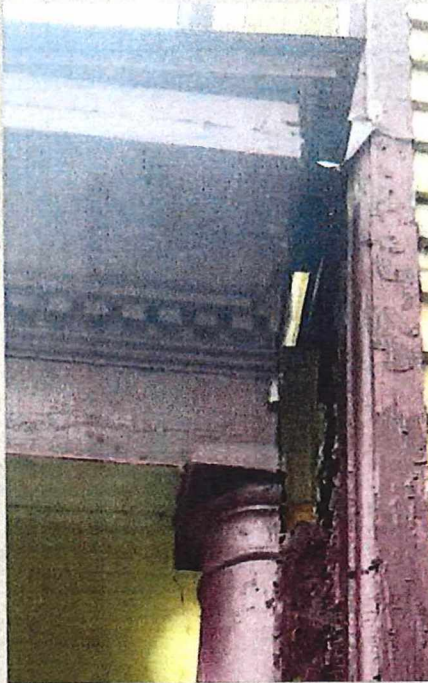
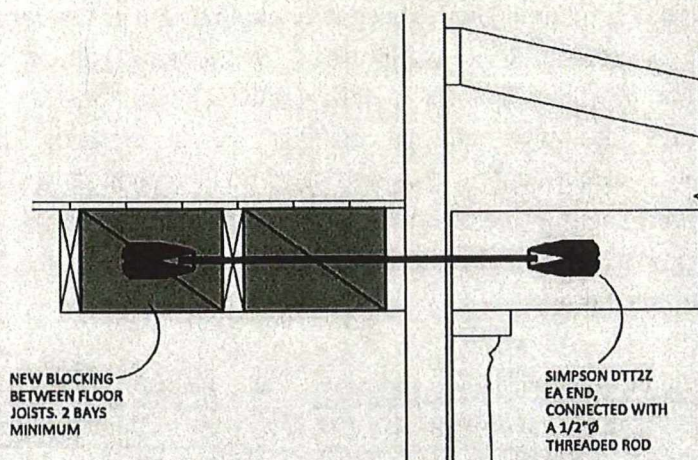
2a.

The roof over the front porch is pulling away from the two-story portion of the home (reference following image). We recommend that the material used to fill this gap (foam and misc. pieces of wood) be removed and that the roof be ratcheted back into place using a come-along or equivalent means. It does not need to be pulled flush to the two-story portion. Reducing the gap down to one and a half inches should be adequate.

The porch roof should then be tied to the two-story framing using two Simpson Strong-Tie DTT2Z Holdowns connected with a 1/2" diameter all

thread rod as shown. Some modification may be necessary for specific conditions encountered. A licensed framing contractor can do this work. Architectural trim pieces and plaster finishes should be removed prior to connecting the metal hardware directly to structural framing.

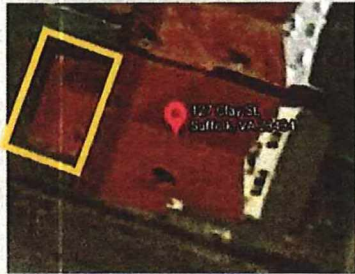
- 3a. The rear single-story addition is experiencing significant foundation settlement. This is due to a lack of rain gutters on the addition, which is causing thousands of gallons of water to be dropped against the foundation. Also due to rain gutter downspouts from the two-story portion emptying their contents near single-story foundation.

Further foundation settlement can be prevented by addressing the excessive saturation of soils beneath and surrounding the foundation, thereby restoring capacity in the soil to support the weight of the structure. This will include hiring a competent rain gutter contractor to install an effective rain gutter system on the back edges of the home, that captures roof runoff and distributes gutter contents to a system of downspouts that are connected to below ground drainpipe that carries gutter contents at least twenty feet away from the foundation to a lower area. While rain gutters and gutter downspouts are installed by a rain gutter contractor, the connected underground drainpipe will be installed by a separate landscaping contractor. Additionally, measures need to be taken to prevent gutter clogging due to falling tree debris. For this reason, we recommend that effective gutter covers be installed over the rain gutters that are designed to screen out tree debris.

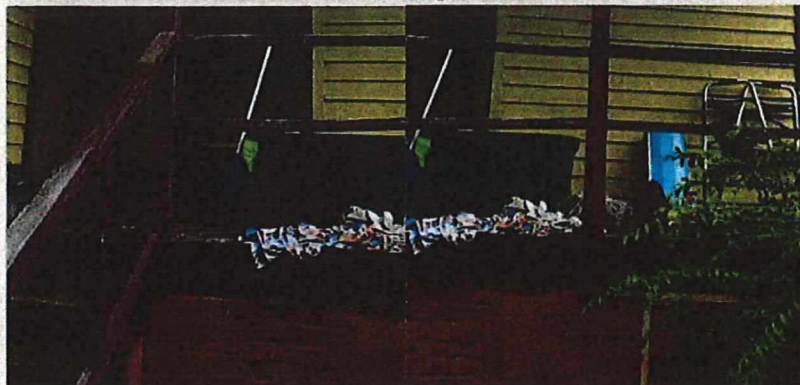
- 5a. The back porch guardrail is unsafe and should be constructed according to current code requirements for guardrails. A qualified licensed framing contractor can assist with this. Construction should conform to the International Residential Code for guardrail construction.

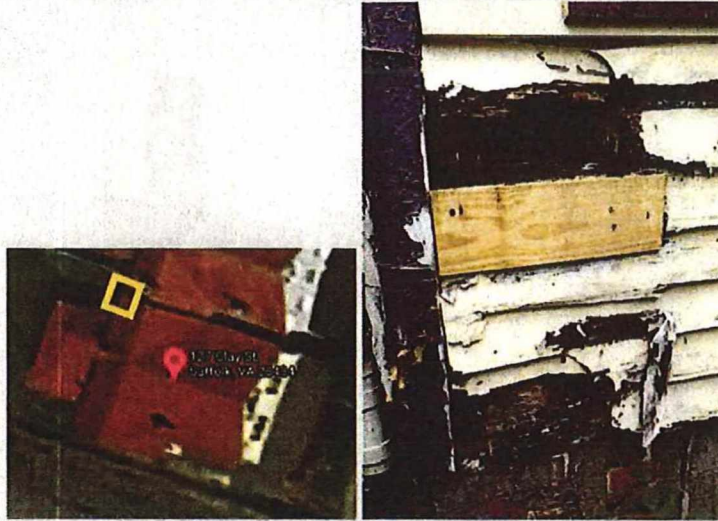
- 6a. Northwest corner of the two-story portion has experienced substantial water and or termite damage. Exterior siding should be removed to expose the full extent of the damaged lumber, which should then be replaced. This is expected to include 6x band board damage, sill plate damage and some vertical stud damage. A licensed framing contractor can perform this work. We strongly recommend against the use of unlicensed contractors.

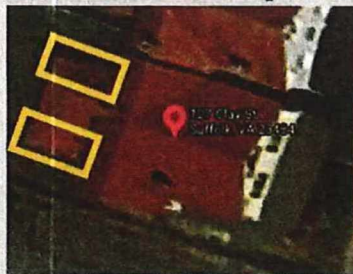
- 10a. There is substantial floor damage at the locations shown on the key map below. This was originally due to leaks, which caused rot and decay under the floor. Subsequently, non-code conforming (and truly appalling) attempts have been made at repair the structure from below.

We recommend that the bathroom and kitchen fixtures and cabinetry in these two areas be demolished and that the flooring and structural subfloor be demolished as well. The underlying framing can then be repaired from both above and below, which is expected to result in better quality. In addition, it will be easier to observe the work to ensure acceptable construction quality has occurred, as opposed to crawling into perform the work entirely from below, which will likely result in further non-conforming construction. This work can be performed by a qualified licensed framing contractor.
